# Army Lodging Wellness Recommendation

## Final Submittal - White Sands Arsenal

February 13, 2004

# White Sands Missile Range

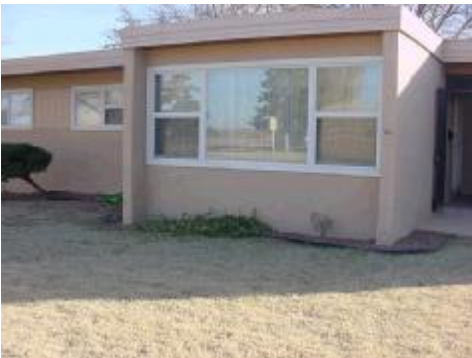
### ***Building 12342***

Building 12342, constructed in 1958, is a one family suite structure. This unit contains a full kitchen, dining area, living room, bathroom and three bedrooms. Although renovated in 1996, this facility does not meet Lodging standards and cannot be reconfigured without significant reconstruction. To renovate Building 12342 to the new standards and configuration would exceed 50% of the replacement cost.

Our recommendation is to remove building 12342 from the Lodging inventory, allowing the installation to determine an alternate use for this facility. This facility will be removed from the White Sands Missile Range Wellness Solution and Lodging Master Plan.

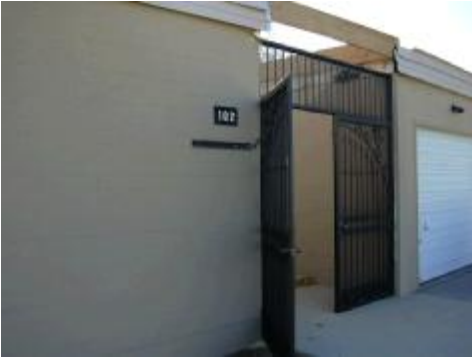
#### ***Building 12343***

Building 12343, constructed in 1958, is a one family suite structure. This unit contains a full kitchen, dining area, living room, bathroom and three bedrooms. Although renovated in 1996, this facility does not meet Lodging standards and cannot be reconfigured without significant reconstruction. To renovate Building 12343 to the new standards and configuration would exceed 50% of the replacement cost.

Our recommendation is to remove building 12343 from the Lodging inventory, allowing the installation to determine an alternate use for this facility. This facility will be removed from the White Sands Missile Range Wellness Solution and Lodging Master Plan.

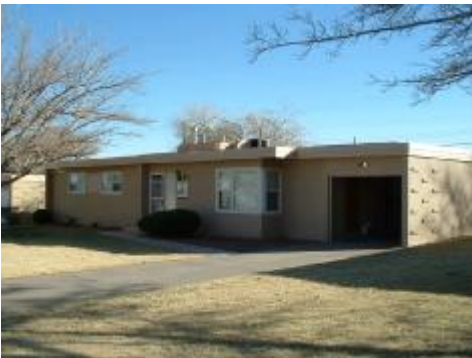
#### ***Building 12344***

Building 12344, constructed in 1958, is a one family suite structure. This unit contains a full kitchen, dining area, living room, bathroom and three bedrooms. Although renovated in 1996, this facility does not meet Lodging standards and cannot be reconfigured without significant reconstruction. To renovate Building 12344 to the new standards and configuration would exceed 50% of the replacement cost.

Our recommendation is to remove building 12344 from the Lodging inventory, allowing the installation to determine an alternate use for this facility. This facility will be removed from the White Sands Missile Range Wellness Solution and Lodging Master Plan.

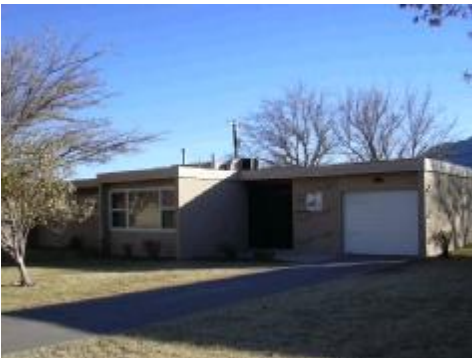
#### ***Building 12345***

Building 12345, constructed in 1958, is a one family suite structure. This unit contains a full kitchen, dining area, living room, bathroom and three bedrooms. Although renovated in 2002, this facility does not meet Lodging standards and cannot be reconfigured without significant reconstruction. To renovate Building 12345 to the new standards and configuration would exceed 50% of the replacement cost.

Our recommendation is to remove building 12345 from the Lodging inventory, allowing the installation to determine an alternate use for this facility. This facility will be removed from the White Sands Missile Range Wellness Solution and Lodging Master Plan.

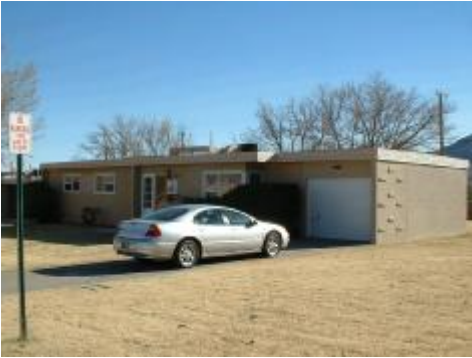
### ***Building 12346***

Building 12346, constructed in 1958, is a one family suite structure. This unit contains a full kitchen, dining area, living room, bathroom and three bedrooms. Although renovated in 2002, this facility does not meet Lodging standards and cannot be reconfigured without significant reconstruction. To renovate Building 12346 to the new standards and configuration would exceed 50% of the replacement cost.

Our recommendation is to remove building 12346 from the Lodging inventory, allowing the installation to determine an alternate use for this facility. This facility will be removed from the White Sands Missile Range Wellness Solution and Lodging Master Plan.

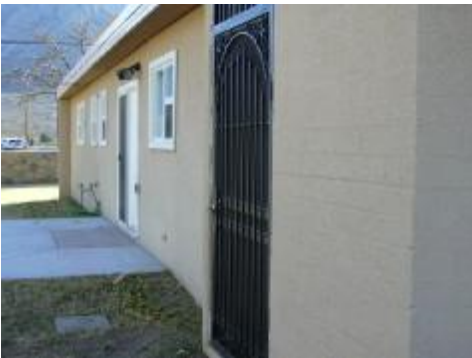
### ***Building 12347***

Building 12347, constructed in 1958, is a one family suite structure. This unit contains a full kitchen, dining area, living room, bathroom and three bedrooms. Although renovated in 1996, this facility does not meet Lodging standards and cannot be reconfigured without significant reconstruction. To renovate Building 12347 to the new standards and configuration would exceed 50% of the replacement cost.

Our recommendation is to remove building 12347 from the Lodging inventory, allowing the installation to determine an alternate use for this facility. This facility will be removed from the White Sands Missile Range Wellness Solution and Lodging Master Plan.

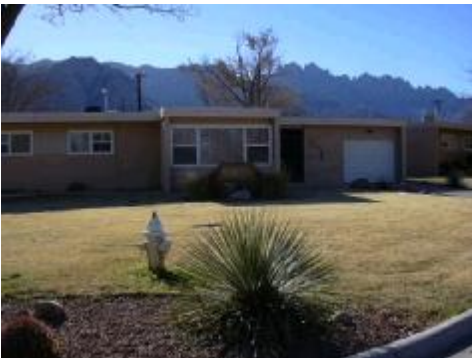
### ***Building 12348***

Building 12348, constructed in 1958, is a one family suite structure. This unit contains a full kitchen, dining area, living room, bathroom and three bedrooms. Although renovated in 2002, this facility does not meet Lodging standards and cannot be reconfigured without significant reconstruction. To renovate Building 12348 to the new standards and configuration would exceed 50% of the replacement cost.

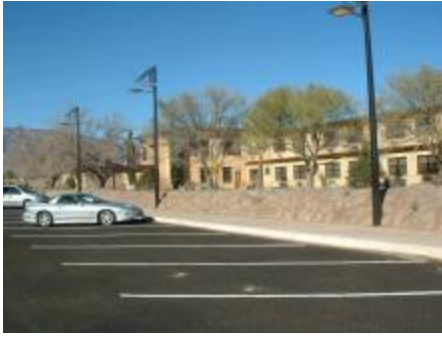
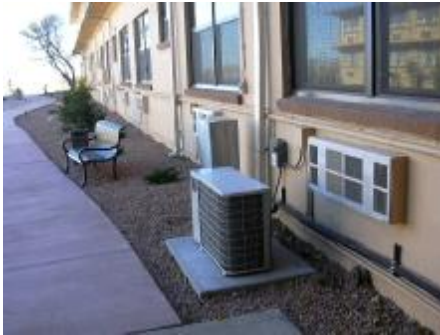
*Bldg 501  
Main Lodging Facility  
White Sands Missile Range, NM*

• Renovation Cost	\$2,788,715
• Replacement Cost	\$2,970,490
• Renovation to Replacement Cost Ratio	93.88%

Because the Renovation to Replacement Cost Ratio is greater than 50.00%, renovation of Building 00501 is not recommended.

Our recommendation is to remove building 501 from the Lodging inventory, allowing the installation to determine an alternate use for this facility. This facility will be removed from the White Sands Missile Range Wellness Solution and Lodging Master Plan.

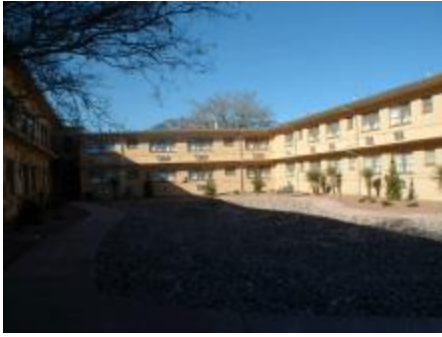
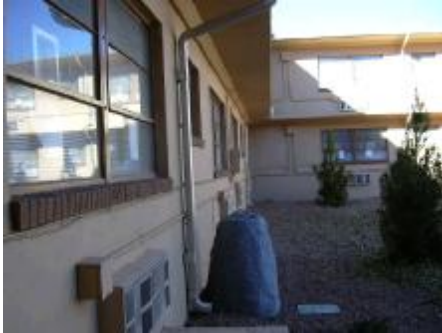
*Bldg 502  
Courtyard View  
White Sands Missile Range, NM*

• Renovation Cost	\$2,178,502
• Replacement Cost	\$3,118,578
• Renovation to Replacement Cost Ratio	69.86%

Because the Renovation to Replacement Cost Ratio is greater than 50.00%, renovation of Building 00502 is not recommended.

Our recommendation is to remove building 502 from the Lodging inventory, allowing the installation to determine an alternate use for this facility. This facility will be removed from the White Sands Missile Range Wellness Solution and Lodging Master Plan.

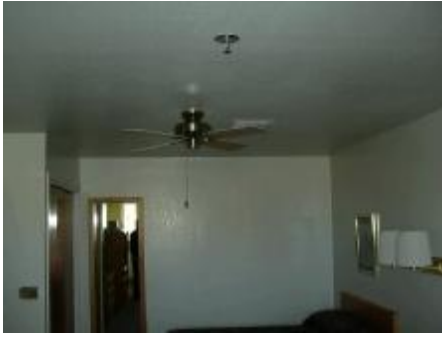
**Bldg 506**  
**Guest Room Ceiling**  
**White Sands Missile Range, NM**

- Analysis: Interior ceiling finishes consist of painted drywall, renewed in 1996. Ceiling finishes are in good condition.
- Recommendation: Paint interior ceilings.

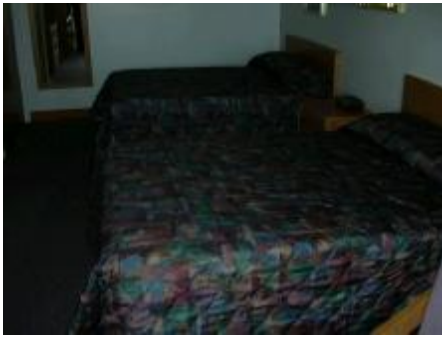
Bldg 506  
Guest Room  
White Sands Missile Range, NM

- Analysis: Guest Rooms: The hard goods most of which were installed in 1996, consist of a headboard, night stand, dresser, 1 or 2 easy chairs, side chair, desk, and TV cabinet. The soft goods, also installed in 1996, consist of drapes on the windows, TV, mattress and box springs and bed coverings. Units have a small kitchen which includes a two burner electric stove top. All are in good condition.
- Recommendation: Replace all hard and soft goods in guest rooms.

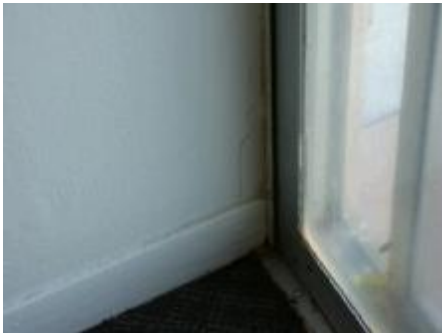
102 Goddard  
Patio Door Damage  
White Sands Missile Range, NM
